Prepared For:
Sample Report

Property Address:
1234 Sample Rd
Sample, AZ 85555

Rogers & Kunnen Inc dba HouseMaster Home and Termite Inspections

Inspection Date: 2/14/2006

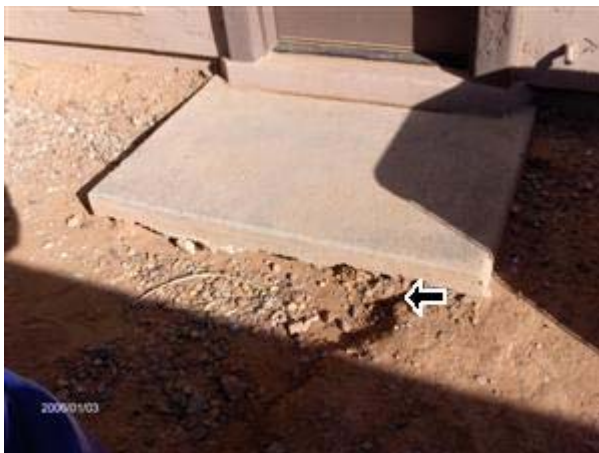
3.7 SITE GRADING Picture 1

●				3.0	PATIO(S)
●				3.1	WALKWAYS
●				3.2	DRIVEWAY
		●		3.3	RETAINING WALL(S)
		●		3.4	WINDOW WELLS
		●		3.5	SUB-GRADE ENTRYWAY
●				3.6	GROUND SLOPE AT FOUNDATION
	●			3.7	SITE GRADING Soil has eroded on the west side by the garage back door. Repair. Landscape is unfinished in the rear yard.

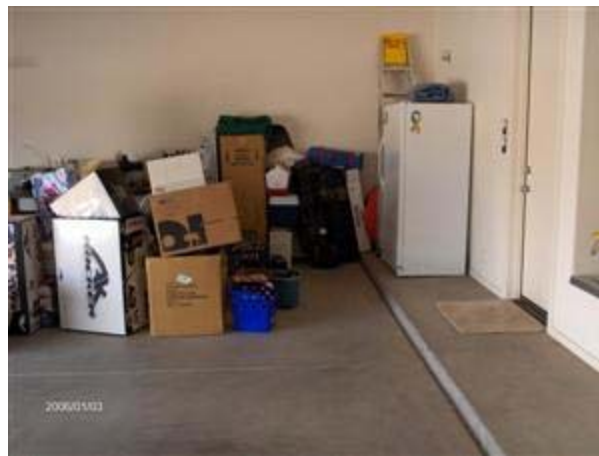
4.2 FLOOR SLAB Picture 1

•					4.0	ROOFING
				•	4.1	EXPOSED FRAMING Framing is covered.
	•				4.2	FLOOR SLAB Storage prevents viewing on the slab and stem walls. Noted termite treatment drill holes on the west wall. See termite report.
	•				4.3	FOUNDATION Storage covering the floor prevents viewing of the floor and foundation. Wiped off termite tube noted on the west stem wall. See termite report and treatment records.
•					4.4	ATTIC VENTILATION
	•				4.5	WALLS / CEILINGS Normal wear.
•					4.6	SIDING
•					4.7	VEHICLE DOOR(S)
•					4.8	DOOR OPERATOR(S) Only the two car door has an opener.
	•				4.9	ELECTRIC / GFCI Recommend refrigerator not be plugged into GFCI.
